Performance and Maintenance of Reinforced Concrete Structures in a Marine Environment: A Case Study of the Port Sudan Seaport Corporation

Ali Mohamed Ali Badi¹, Abdalla Eissa Abdelkarim²

HNSJ, 2025, 6(12); <https://doi.org/10.53796/hnsj612/17>

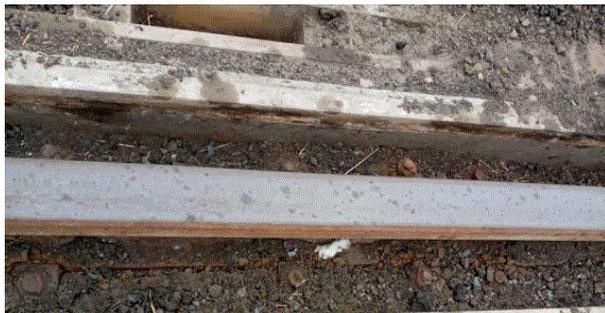
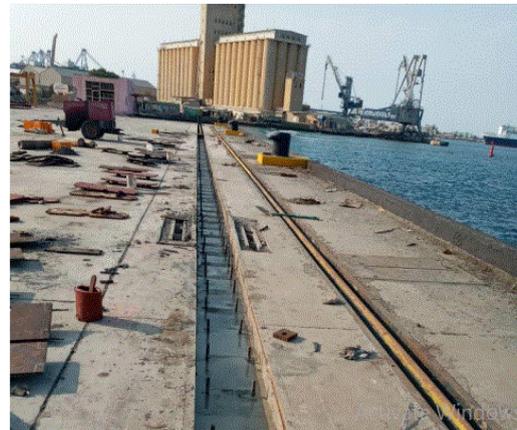
- **Concrete Deterioration:** Spalling and delamination were observed on the parapets of Berths 13-14 and 21-24, and on the service trench covers. This was particularly severe in areas with high exposure to wave splash and saltwater spray.
- **Reinforcement Corrosion:** Corrosion of steel was evident in the crane rails of Berths 13-14, the extension of Berths 17-18, and the four rails of Slipway No. 1.
- **Physical Damage:** Damage to rubber fenders was a common issue across the berths.
- **Abrasion:** The retaining walls of Slipway No. 1 showed surface deterioration due to mechanical abrasion.

Two photos show the corroded crane rail and its repair

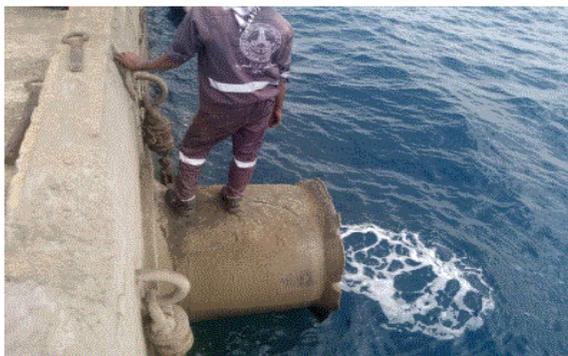
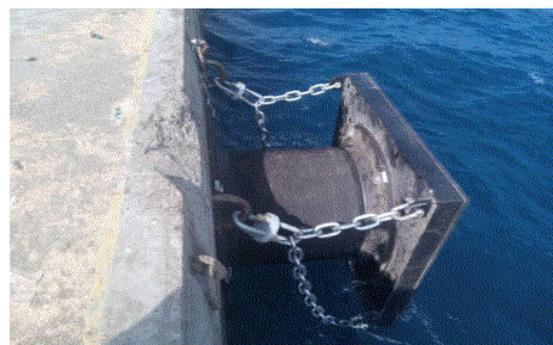
Two photos show damage to a rubber fender and a newly installed rubber fender

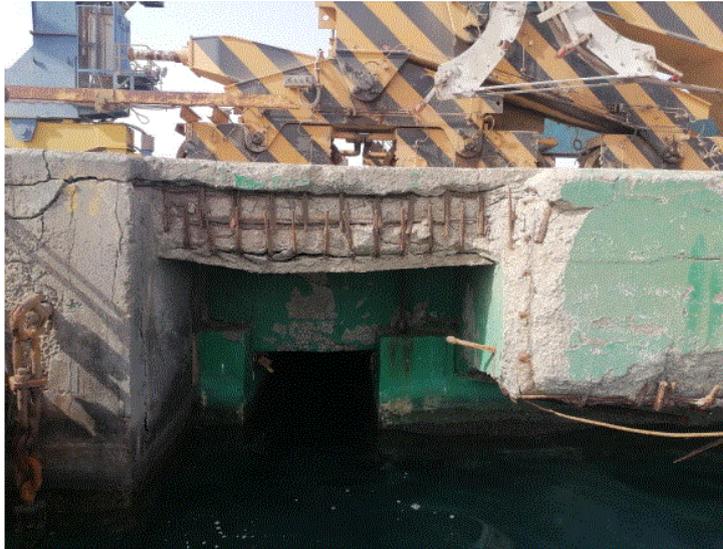
Photo show sample of corrosion in the berth 17/18

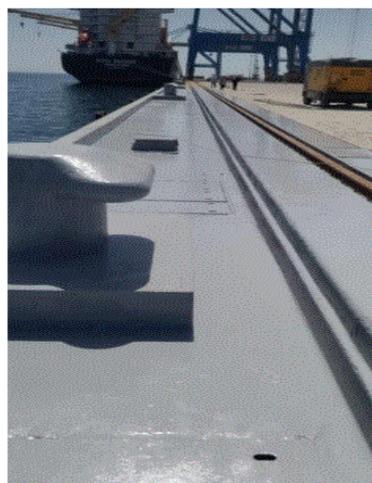
Photo show coated surface with Dekguard PU at berth 13/14

- **General Patch Repair:** Ordinary Portland Cement was used for routine maintenance. For more critical repairs, Sika Rep®, a single-component cementitious mortar, was used for deteriorated concrete on both horizontal and vertical surfaces. X-Tile Construction Grout, a non-shrink cementitious grout, was used for patching thin horizontal layers.
- **Structural Bonding and Anchoring:** Sikadur®-31CF, a two-component epoxy-based adhesive mortar, was used for anchoring bolts and for bonding new concrete to old in the repair of crane rails.
- **Protective Coating:** To prevent future chloride ingress, Fosroc Dekguard PU, a high-performance polyurethane coating, was applied to the top surface of Berths 13-14 over an area of 3905 m² (5m width from the apron edge).
