**Using GIS and NDVI applications to evaluate Storm Daniel impacts on El-Gabal El-Akhdar Area-Libya: Wadi El-kof as example****Salem Elshatshat<sup>1\*</sup>, Fatima Alsaeh,<sup>2</sup> and Abd Elrahmann El shatshat<sup>3</sup>**

HNSJ, 2024, 5(2); <https://doi.org/10.53796/hnsj52/16>

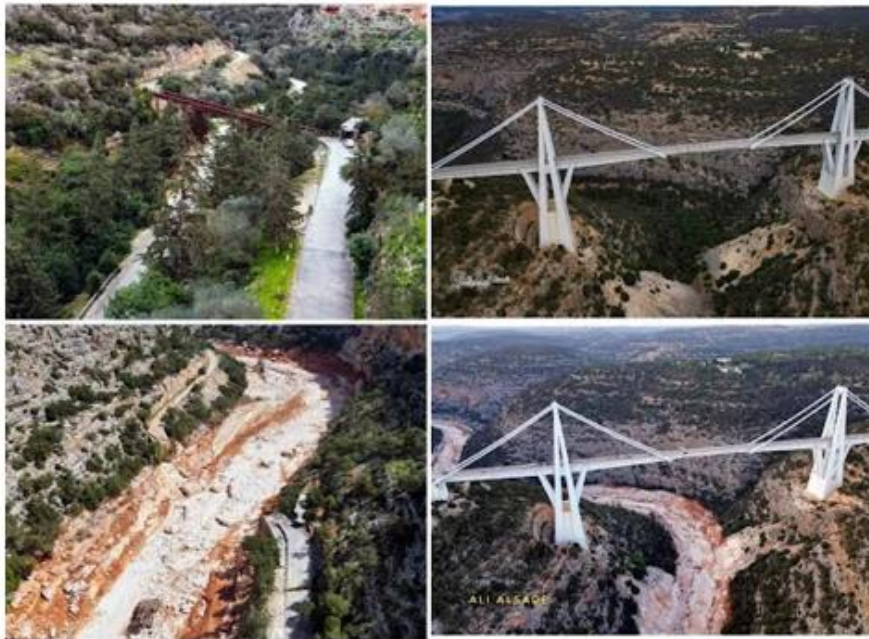
**Figure 2.** The catastrophic effect of Storm Daniel on Wadi Al kuf area from different locations. Left up, the wadi with the old bridge which established during Italian occupation before the flooding, and down, the devastation caused by the catastrophic flooding. Note the absence of the bridge, roads and vegetation. Right up the wadi new bridge. Note the differences between before flooding “up” and after flooding “down”. Photos were captured by the Libyan photographer Ali Al saadi (Al saadi, A., personal communication, October 10, 2023).

As shown in figure 2, 3, and 4, the field visits to the study area revealed the devastation caused by the catastrophic flooding. Clearly the rainfall associated with Storm Daniel was extreme and there is no doubt that the magnitude of the damage indicates that a rainfall-induced river flood was formed. This large total might have exceeded the Wadi structure which naturally is not adapted to like this climatic changes and subsequently, avoid serious damage.

Water-induced soil erosion high values were observed in the study area that exposed to heavy rains (Figure 4). Despite the soil erosion varied from low to high erosion, but here, the effects of Storm on soil were very high while a Hugh number of tons of soils and sediments transport in highly variable spatially processes (Figure 4). Even though the vegetation coverage in the Wadi channels and on the side banks before the flooding was characterized as aged, rough and dense, but this could not prevent the erosion (Figure 2). The most likely scenario is, that

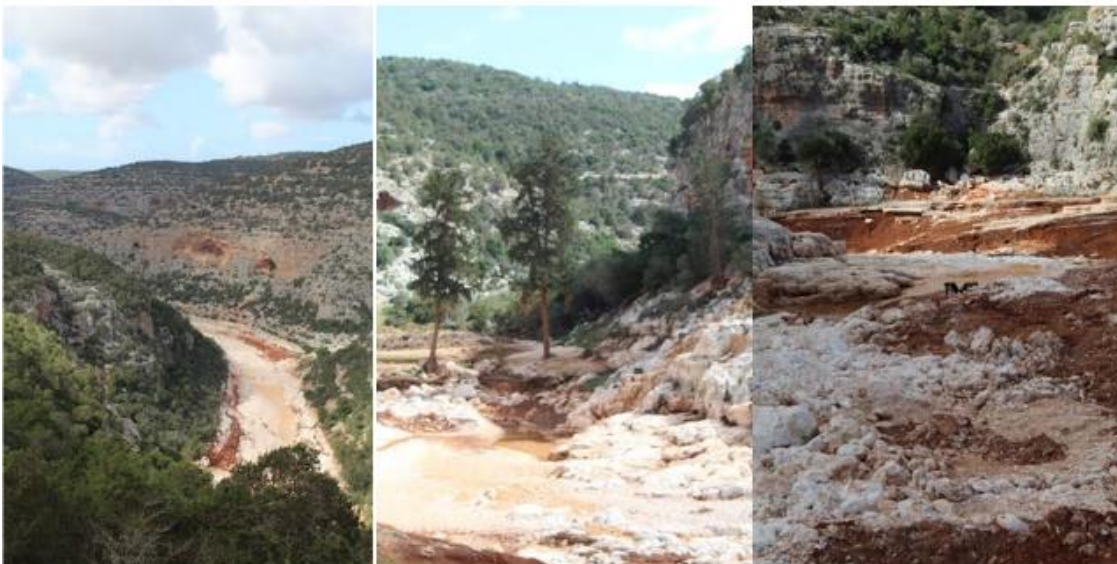
**Figure 3.** The erosion and absence of vegetation from Wadi channel, banks and slopes of the mountain.

Vegetation Cover is one of most important biophysical indicator to soil erosion, which can be estimated using vegetation indices derived from the Satellite images. Repetitive and seasonal flash floods, occur in different countries like those in Mediterranean and north Africa (Hallouz et al., 2018; Almasalmeh et al., 2022; Azab et al., 2021), entails the soil layer by erosion and carry spatially large quantities of water and soil sediments (Singh et al. 2020). Azab et al., (2021), found that more than 5500 ton of sediments of Wadi Naghamish (Egypt) reached the wadi outlet. And the highest values were found in the sloping areas. Despite the flood is un-repetitive, this finding can be noticed in Wadi Al-Kuf (Figure 3 and 4).

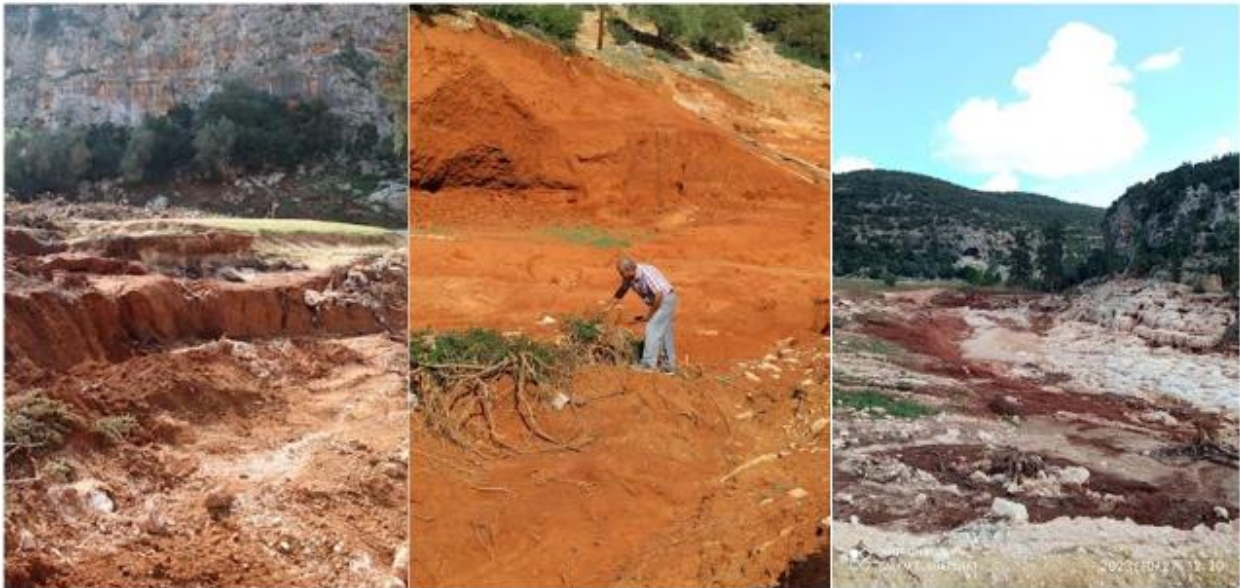
**Figure 4.** The soil erosion of the channel and banks of Wadi Al kuf. appearance of white rocks and eroded alluvial soil is clearly notable
